Pattern of Gully Characteristics under Different Land use Practices in Gboko Town, Benue State, Nigeria

Abstract

Keywords: Gully characteristics, Built-up and un-built areas, Land-use, Gboko town.

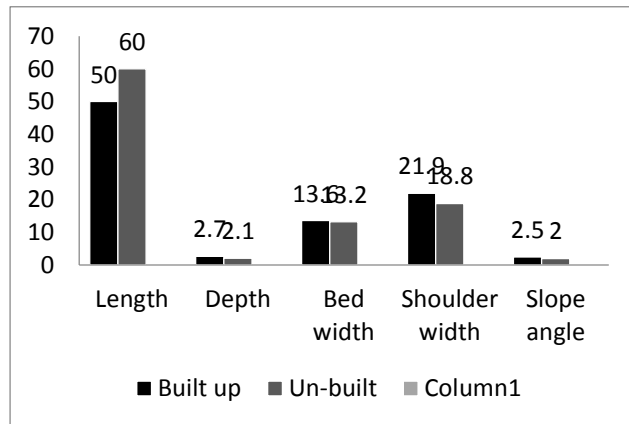
Figure 3: Gully Elements in the Built and Un-Built Areas of Gboko North

The result of 4 gullies measured from the built up areas revealed that all the gullies are short ranging from 40m to 80m. The depth of the gullies ranges from 0.8 to 3.8m with the deepest point found with the gully in Gboko north. The gully bed width on the other hand ranges from

9.8 to 24.3m while the gully shoulder width ranges from 18.3 to 36m. The slope angle of gullies under this land use practice varies from 1 to 5°. The gully in Gboko north lies along Adi Street, evidently initiated as a result of the failed drainage attempts where a culvert was constructed without proper linkage to the drainage channel. The gully empties at Aungwa stream and the gully bed is littered with sand stones that results to a rough gully bed and walls. The presence of resistant materials (strong sand stones and clay) at the gully banks and bed at varying intervals results in the irregular depth and width of the gully. The gully has the total length of 50m and the mean depth of 2.7m, its bed and shoulder widths have means of 13.6m and 21.9m respectively with a mean slope of 2.5°. (Figure 3-6). The gully measured in Gboko South lies behind St Thomas primary school and is believed to have resulted from the steep slope adjacent to Kamkigh stream. The gully head is

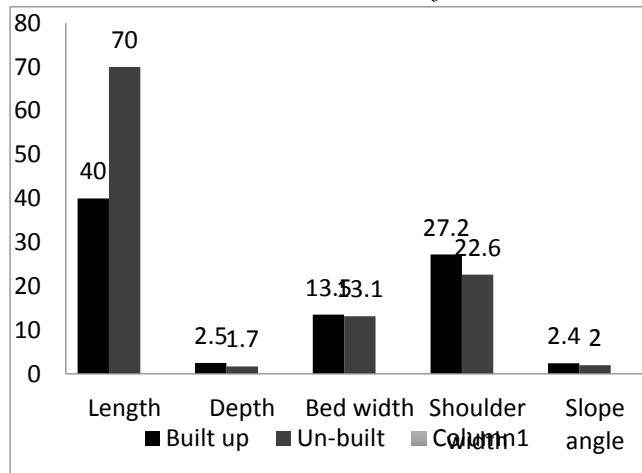
Figure 4: Gully Elements in the Built and Un-built Areas of Gboko South

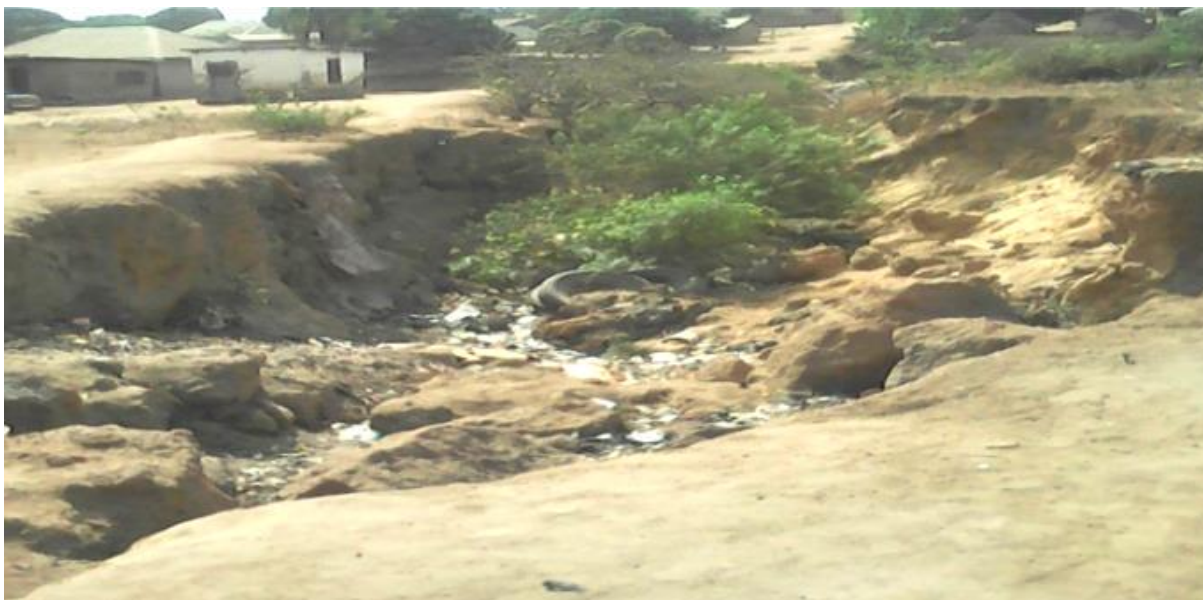
Plate 1: A typical gully head in a built-up area (St. Thomas Primary School) in Gboko: Note: The gully wall recession and presence of waste materials in the gully channel. Photo by: The Authors, January, 2017.

The further description of the gully in the built-up area of Gboko town was done based on the observations made during data collection presented on Plate1.

The gullies from the built up areas of Gboko town as observed during data collection show distinct characteristics with wider bed and shoulder widths. The gully in Gboko North and East were observed to have dominated with resistance materials of different nature including hardened sandstones which give rise to varying depth and width along the gully course. There were also evidence of diverse gully control measures put in place by the residence to reduce the gully effects including the planting of bamboo trees and banana trees. Culverts and buildings were also observed to be exposed and out crust as the surroundings were washed away by gully erosion. The gullies from the south and east of Gboko indicated active gully processes at the banks as wider wall recession is observed of the gullies resulting to wide gully shoulder widths. This implies that there are more resistance materials in the sub soils in the area than in the top soils. The gullies observed in these areas have their beds inflicted with different waste materials generated from households including polythene, package water

bags, yam peels as well as stones, pebbles and rock fragments of different sizes. All the gullies observed from this land use practice have posed a great threat to the buildings like St Francis Parish fence (Gboko East), Mr. Akaangee's house (Gboko south) as can be seen on Plate1.
